2004-06 ACCESSORIES & EQUIPMENT Power Lumbar Support - MDX

COMPONENT LOCATION INDEX

'04-06 Touring models

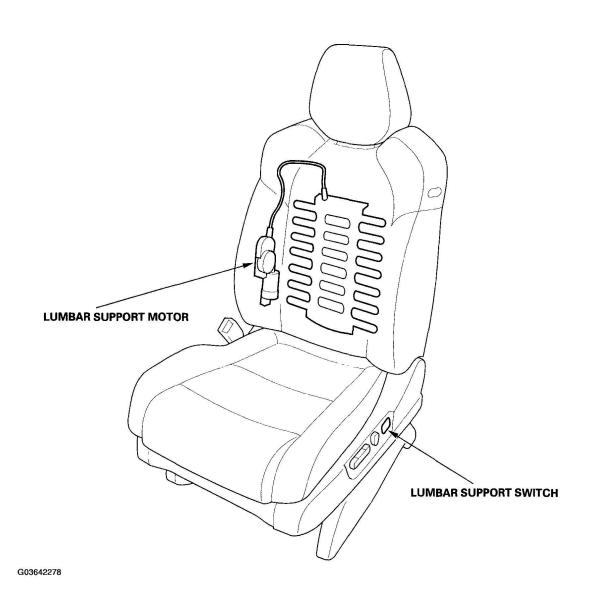
Fig. 1: Identifying Power Lumbar Support Components ('04-06 Touring Models) Courtesy of AMERICAN HONDA MOTOR CO., INC.

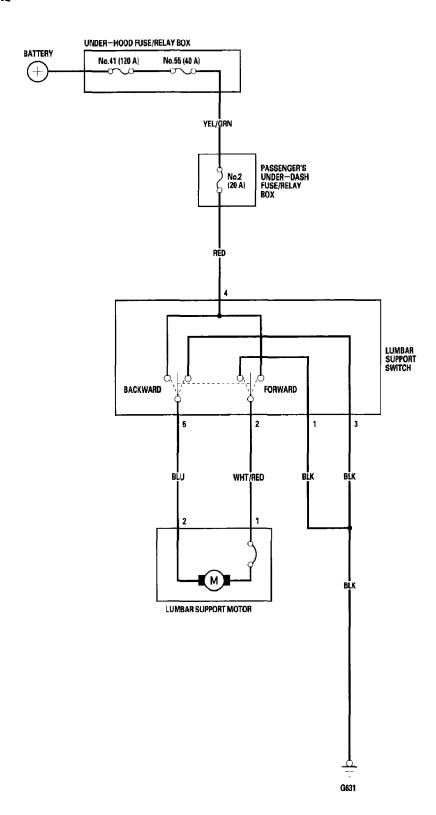
Fig. 2: Circuit Diagram - Power Lumbar Support ('04-06 Touring Models) Courtesy of AMERICAN HONDA MOTOR CO., INC.

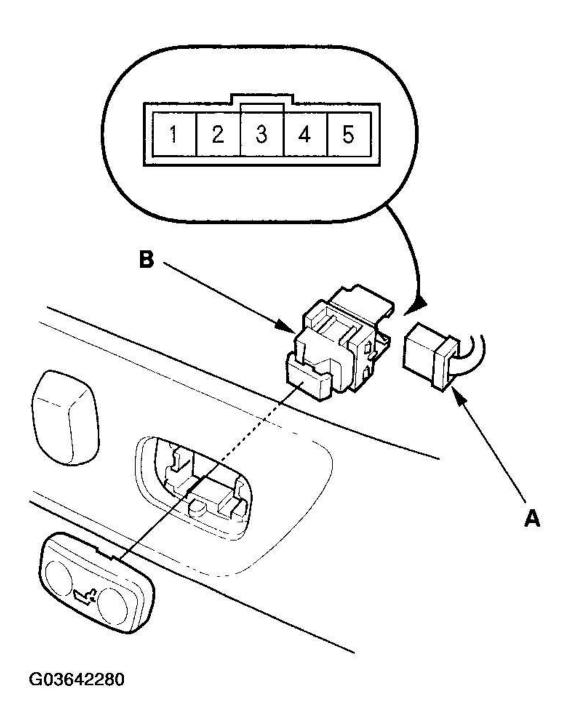
- 1. Remove the recline cover (see '04-06 MODELS').
- 2. Disconnect the 5P connector (A) from the lumbar support switch (B).

Fig. 3: Disconnecting 5P Connector From Lumbar Support Switch Courtesy of AMERICAN HONDA MOTOR CO., INC.

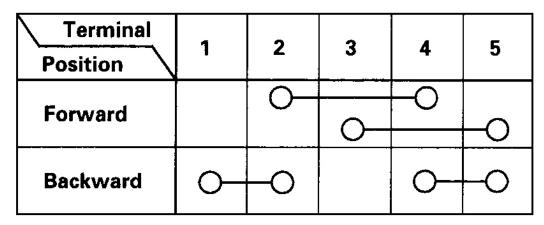
G03642281

- 3. Carefully remove the switch from the recline cover.
- 4. Check for continuity between the terminals in each switch position according to **Fig. 4**.

Fig. 4: Checking Continuity Between Terminals In Each Switch Position Chart Courtesy of AMERICAN HONDA MOTOR CO., INC.

5. If the continuity is not as specified, replace the switch.

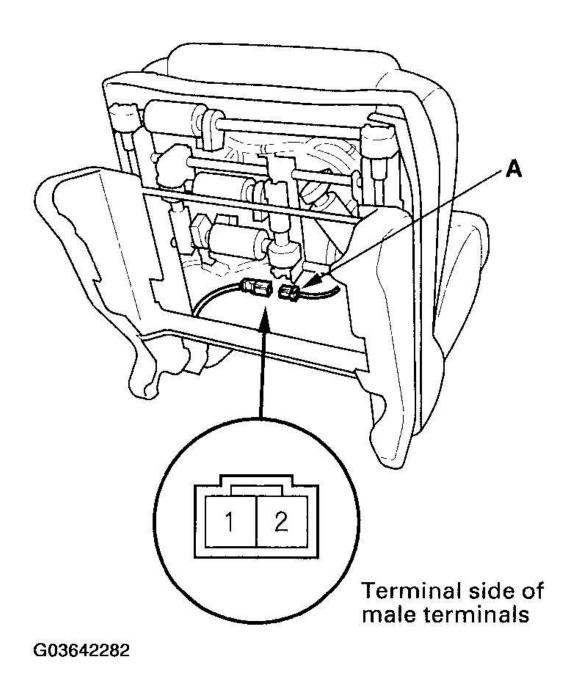
- 1. Remove the driver's seat (see **FRONT SEAT REMOVAL/INSTALLATION**).
- 2. Disconnect the 2P connector (A) from the lumbar support motor.

Fig. 5: Disconnecting 2P Connector From Lumbar Support Motor Courtesy of AMERICAN HONDA MOTOR CO., INC.
