## 2006 Acura MDX

2003-06 RESTRAINTS SRS (Supplemental Restraint System) - MDX

#### SRS (Supplemental Restraint System) - MDX

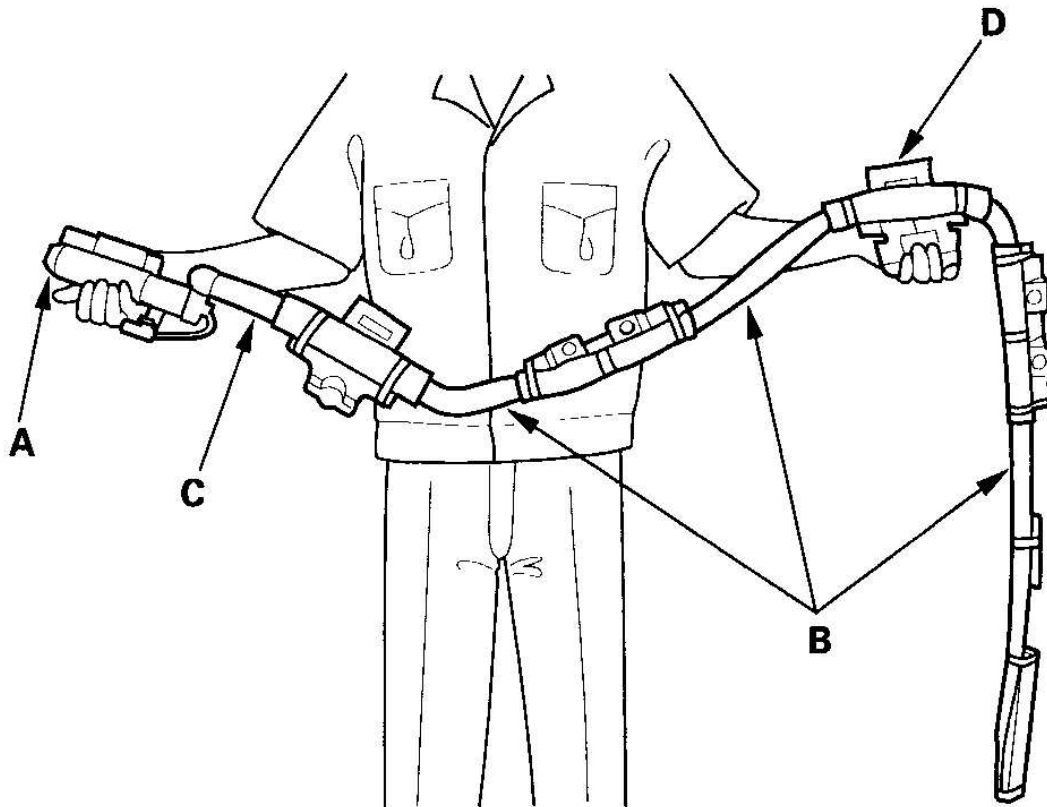
- For proper disposal of a damaged airbag, refer to airbag disposal (see **AIRBAG DISPOSAL** ).
- The is a long, jointed part containing an inflator (A), a flexible bag (B), an adapter (C), and a center bracket (D).

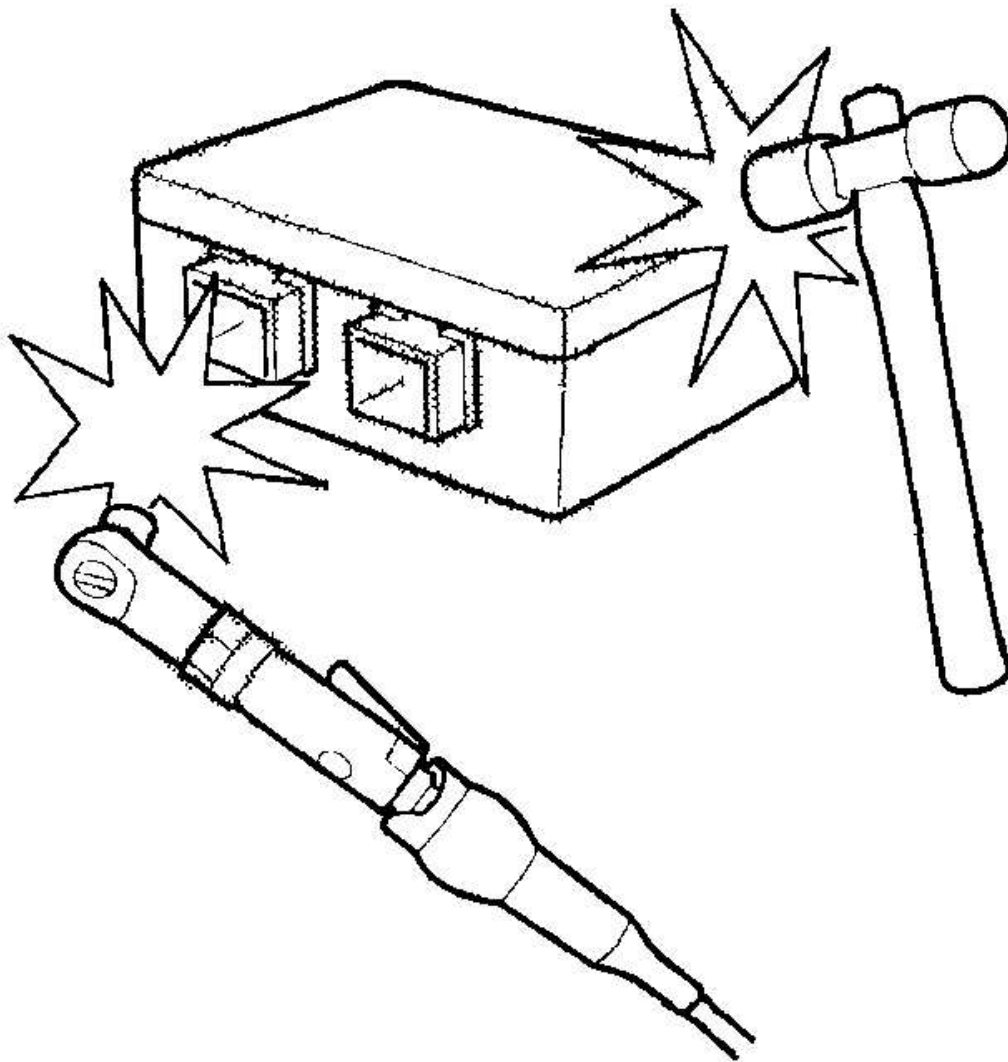
- Be careful not to bump or impact the SRS unit, front impact sensors, side impact sensors, or roll rate sensor whenever the ignition switch is ON (II), or for at least 3 minutes after the ignition switch is turned OFF.
- During installation or replacement, be careful not to bump (by impact wrench, hammer, etc.) the area around the SRS unit, front impact sensors, the side impact sensors, or roll rate sensor. The airbags could accidentally deploy and cause damage or injury.

**Fig. 10: Precaution During Installation Or Replacement Of SRS Unit**  
Courtesy of AMERICAN HONDA MOTOR CO., INC.

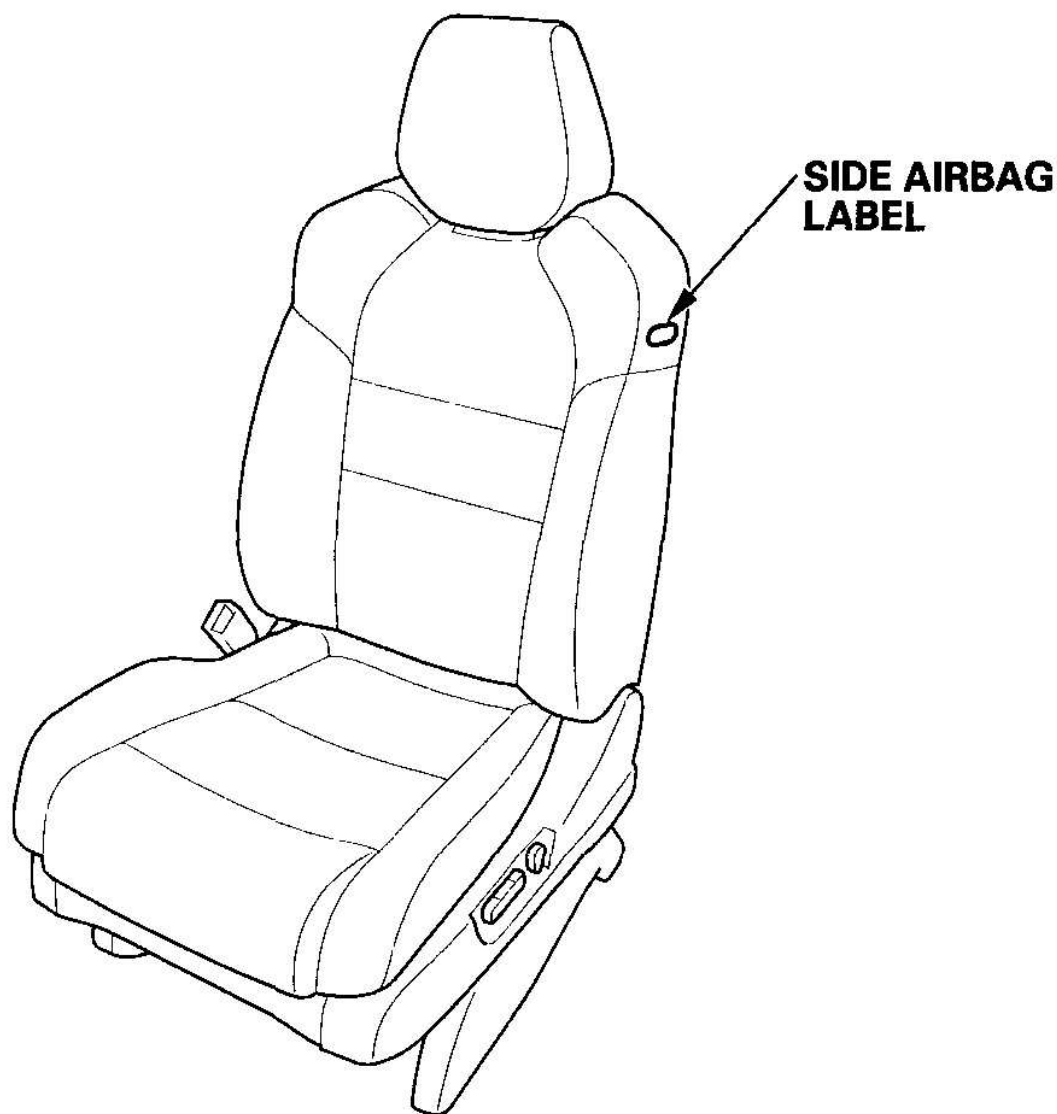
G03642912

Seats with side airbags have a "SIDE AIRBAG" label on the seat-back. Because the component parts (seat-back cover, cushion, etc.) of seats with and without airbags are different, make sure you install only the correct replacement parts.

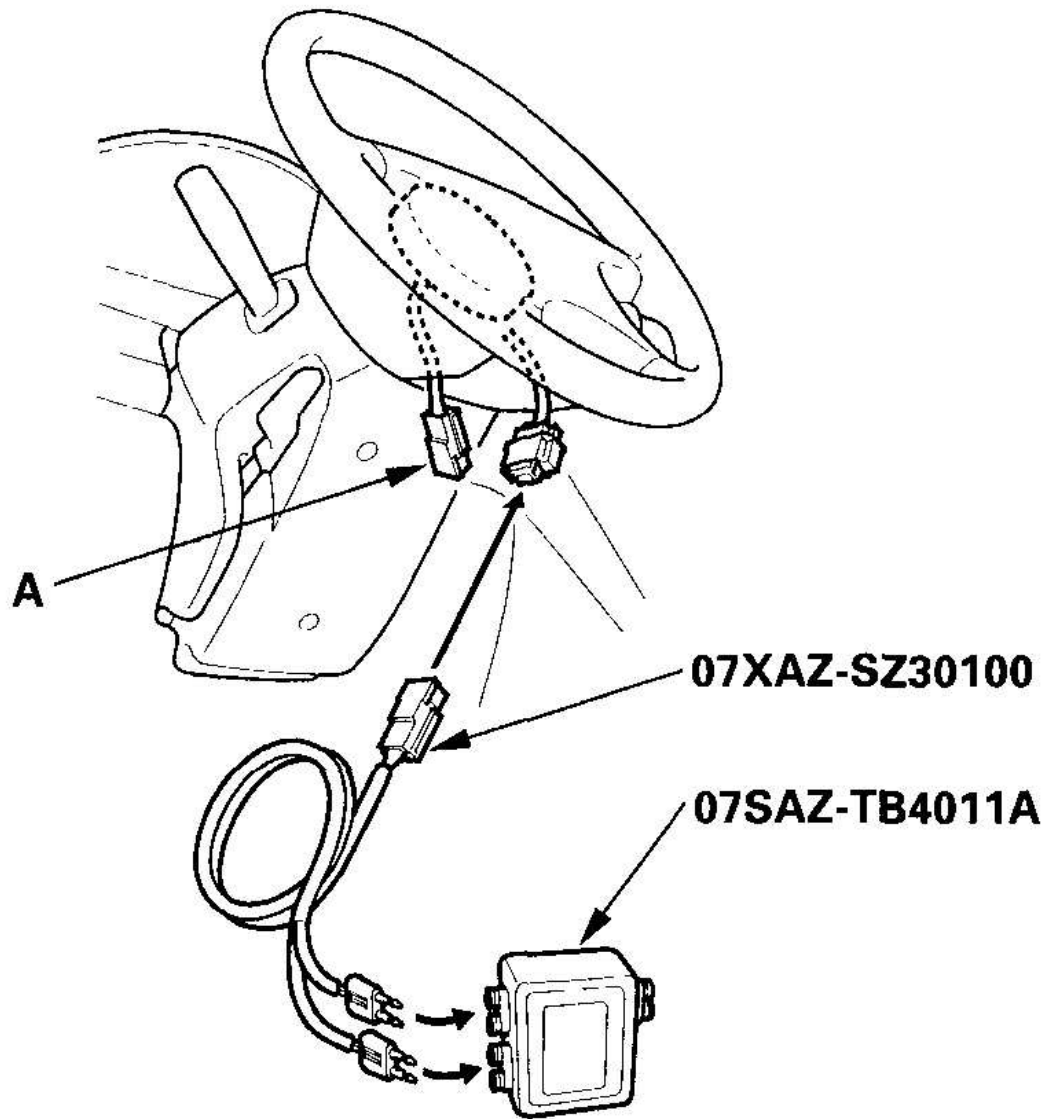
**G03642937**

3. Turn the ignition switch OFF. Disconnect the battery negative cable, and wait for 3 minutes.
4. Disconnect the driver's airbag 4P connector (A) from the cable reel.

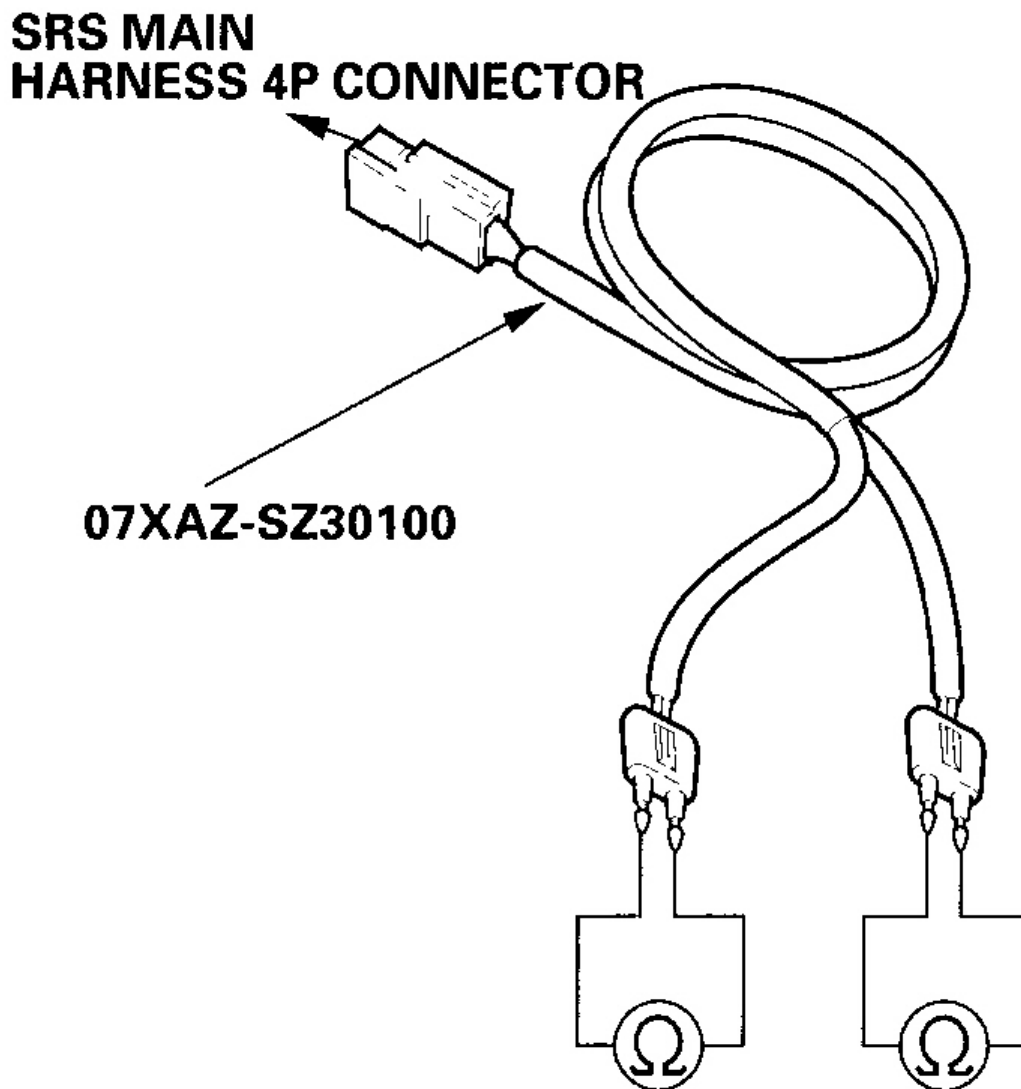
15. Turn the ignition switch OFF. Disconnect the battery negative cable, and wait for 3 minutes.
16. Disconnect the SRS unit connector A(28P) from the SRS unit (see **SRS UNIT** ). Do not disconnect the simulator lead from the SRS main harness 4P connector.
17. Disconnect the SRS inflator simulator from the SRS simulator lead.
18. Check resistance between the terminals of both SRS simulator leads. There should be 1 ohm or less.

**G03642939****Fig. 54: Checking Resistance Between Terminals Of Both SRS Simulator Leads**

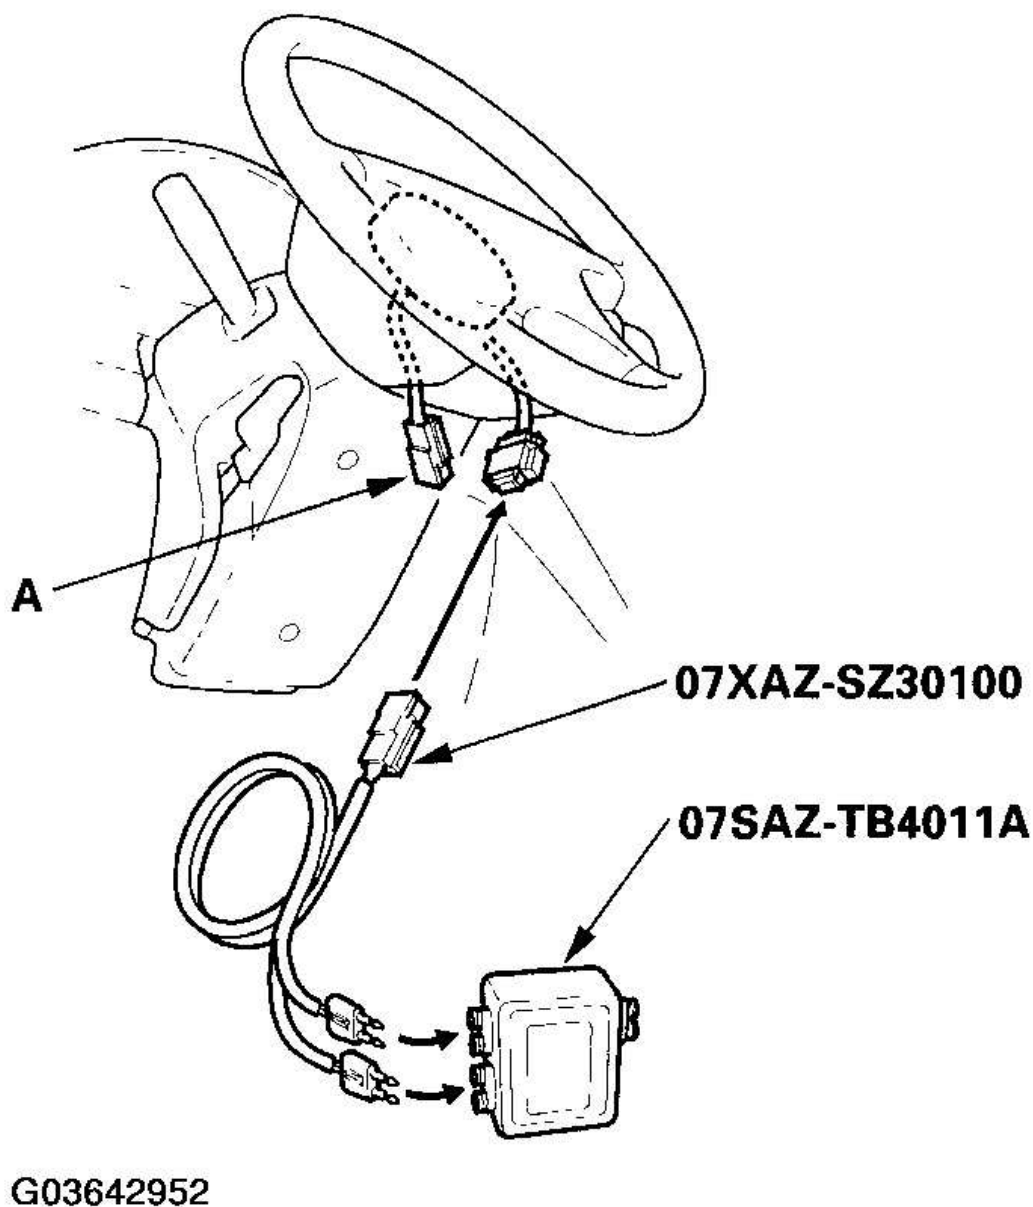
3. Turn the ignition switch OFF. Disconnect the battery negative cable, and wait for 3 minutes.
4. Disconnect the driver's airbag 4P connector (A) from the cable reel.

**Fig. 67: Disconnecting Driver's Airbag 4P Connector From Cable Reel**  
Courtesy of AMERICAN HONDA MOTOR CO., INC.

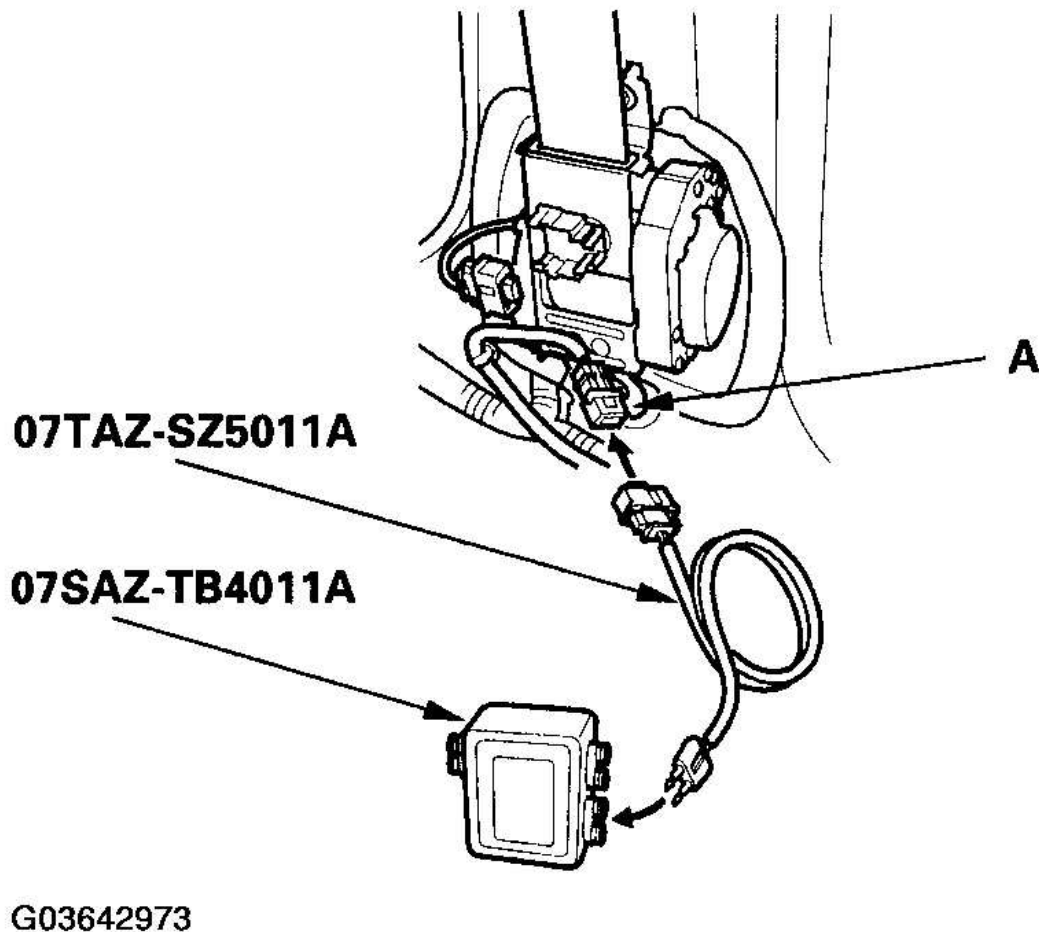
3. Turn the ignition switch OFF. Disconnect the battery negative cable, and wait for 3 minutes.
4. Disconnect the driver's seat belt tensioner 2P connector from the SRS left side subharness (A).

**Fig. 88: Disconnecting Driver's Seat Belt Tensioner 2P Connector From SRS Left Side Subharness**  
Courtesy of AMERICAN HONDA MOTOR CO., INC.

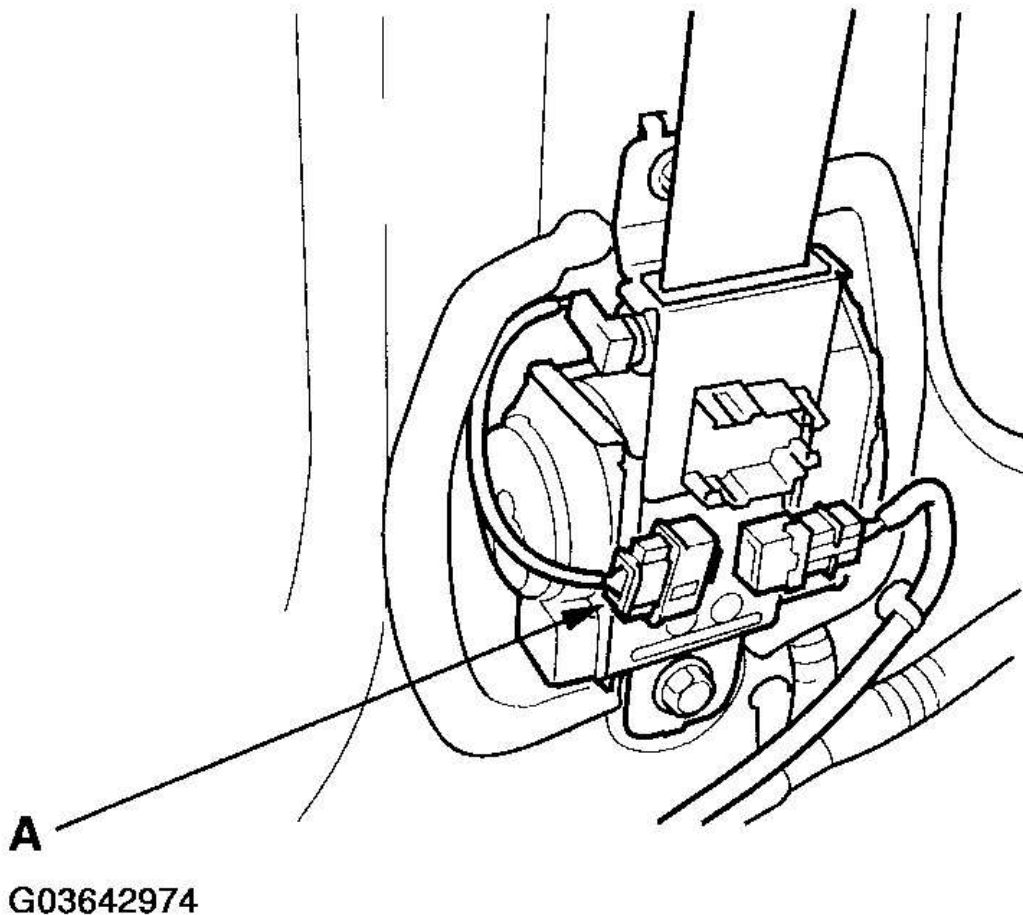
9. Turn the ignition switch OFF. Disconnect the battery negative cable, and wait for 3 minutes.
10. Disconnect the front passenger's seat belt tensioner connector (A).

**Fig. 89: Disconnecting Front Passenger's Seat Belt Tensioner Connector**  
Courtesy of AMERICAN HONDA MOTOR CO., INC.

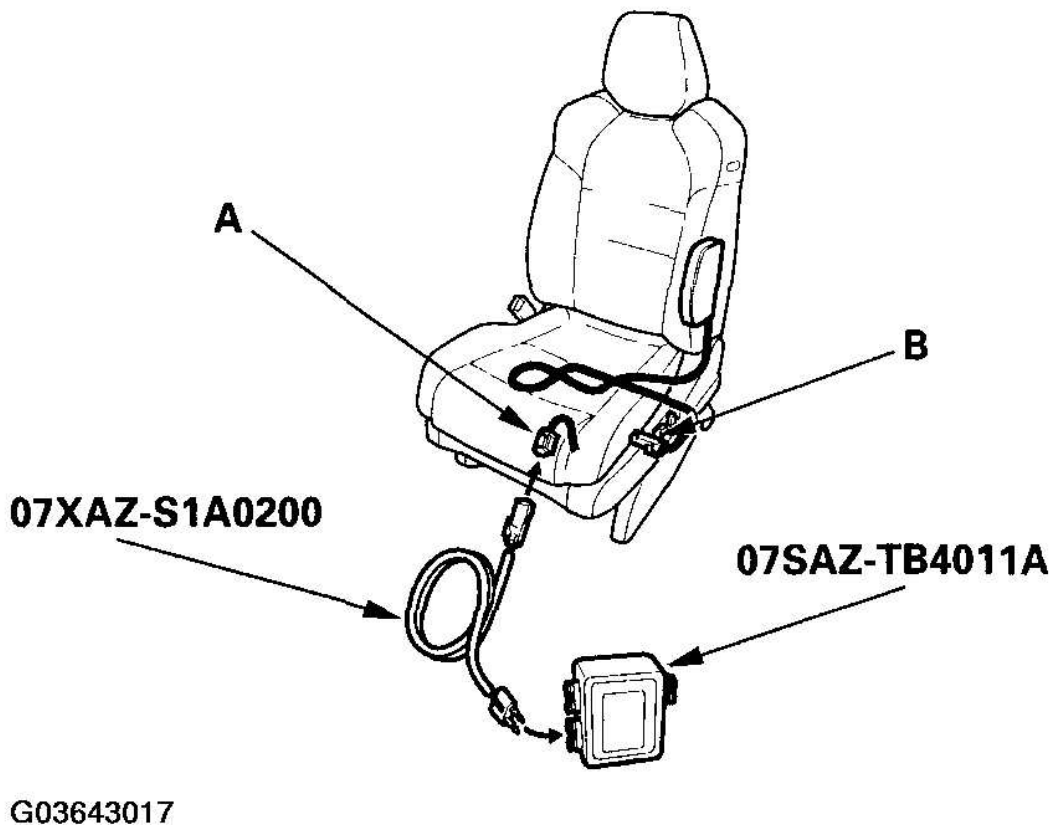
3. Turn the ignition switch OFF. Disconnect the battery negative cable, and wait for 3 minutes.
4. Disconnect the SRS left side subharness 2P connector (A) from the driver's side airbag (B).

**Fig. 132: Disconnecting SRS Left Side Subharness 2P Connector**  
Courtesy of AMERICAN HONDA MOTOR CO., INC.

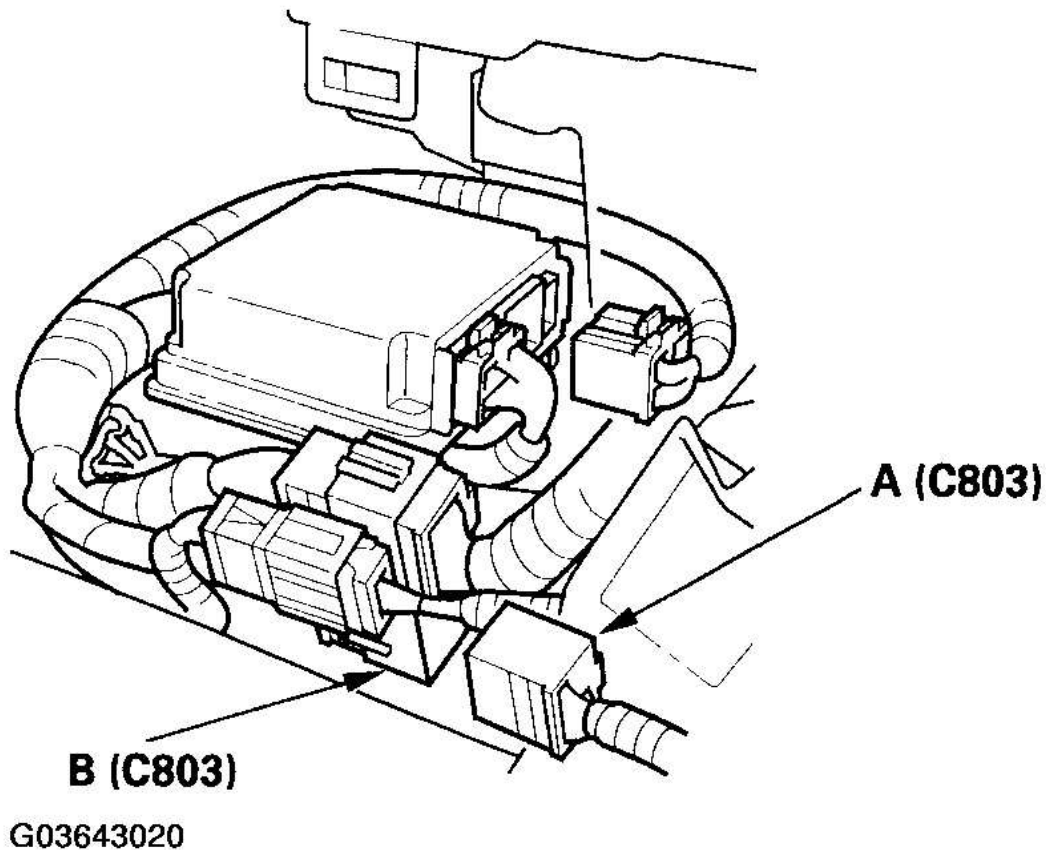
14. Disconnect the SRS left side subharness 28P connector C803 (A) from SRS main subharness connector C803 (B).

**Fig. 135: Disconnecting SRS Left Side Subharness 28P Connector C803**  
Courtesy of AMERICAN HONDA MOTOR CO., INC.

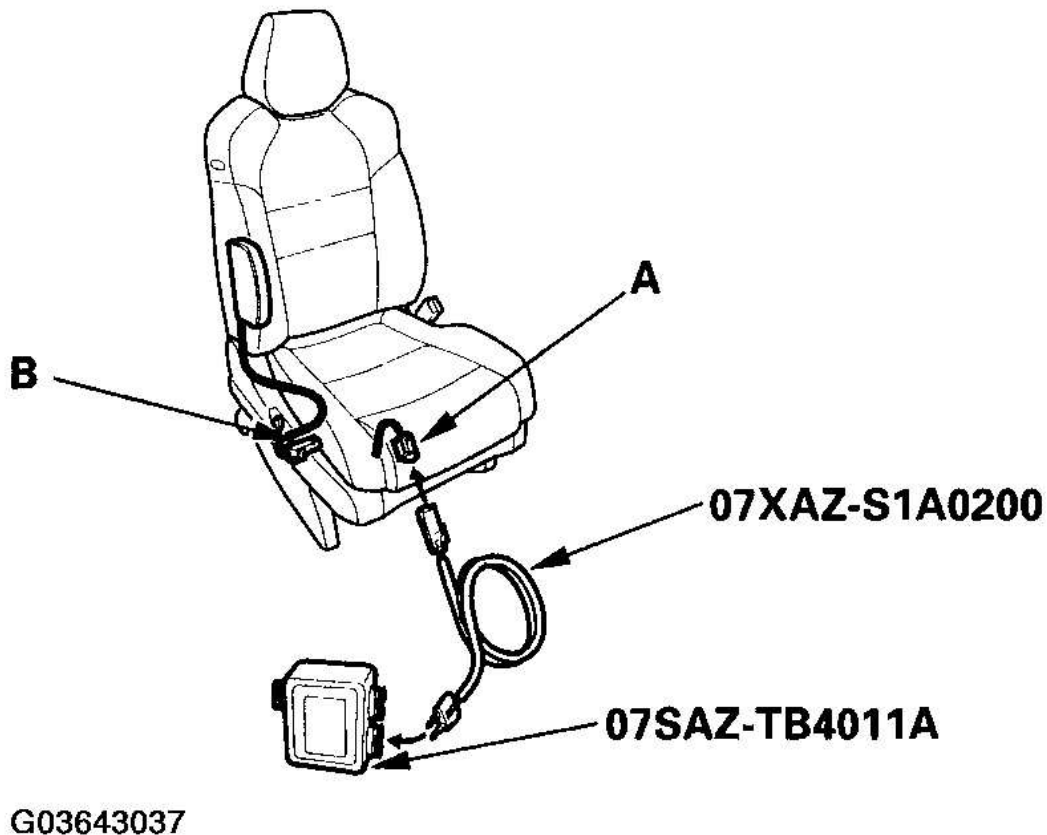
3. Turn the ignition switch OFF. Disconnect the battery negative cable, and wait for 3 minutes.
4. Disconnect the SRS right side subharness 2P connector (A) from the front passenger's side airbag (B).

**Fig. 152: Disconnecting SRS Right Side Subharness 2P Connector**  
Courtesy of AMERICAN HONDA MOTOR CO., INC.

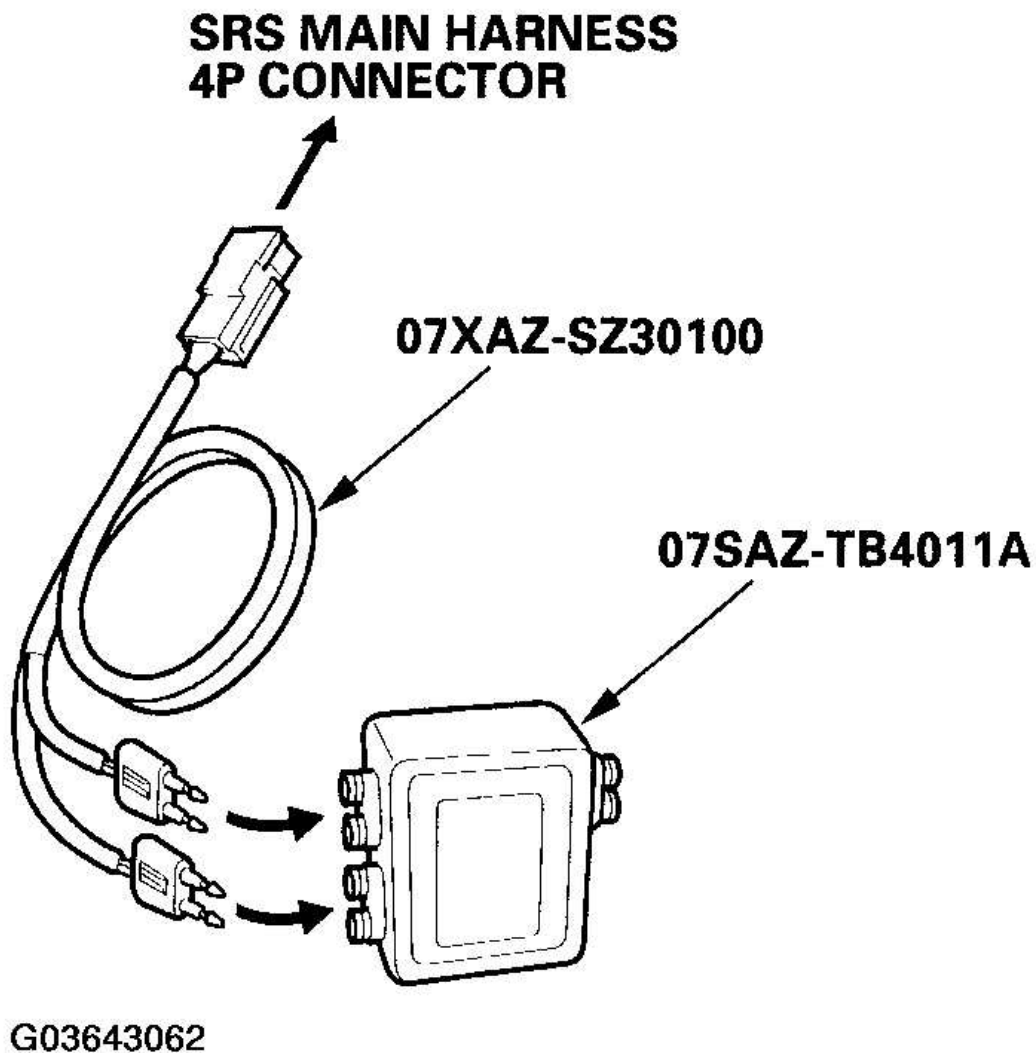
9. Turn the ignition switch OFF. Disconnect the battery negative cable, and wait for 3 minutes.
10. Disconnect roof wire harness 4P connector C812 from the SRS main harness 4P connector (see **ROOF WIRE HARNESS ('04 MODEL)** ).
11. Connect the SRS inflator simulator (2 ohm connectors) and simulator lead F to the SRS main harness 4P connector.

**Fig. 177: Connecting SRS Inflator Simulator And Simulator Lead F To SRS Main Harness 4P Connector**

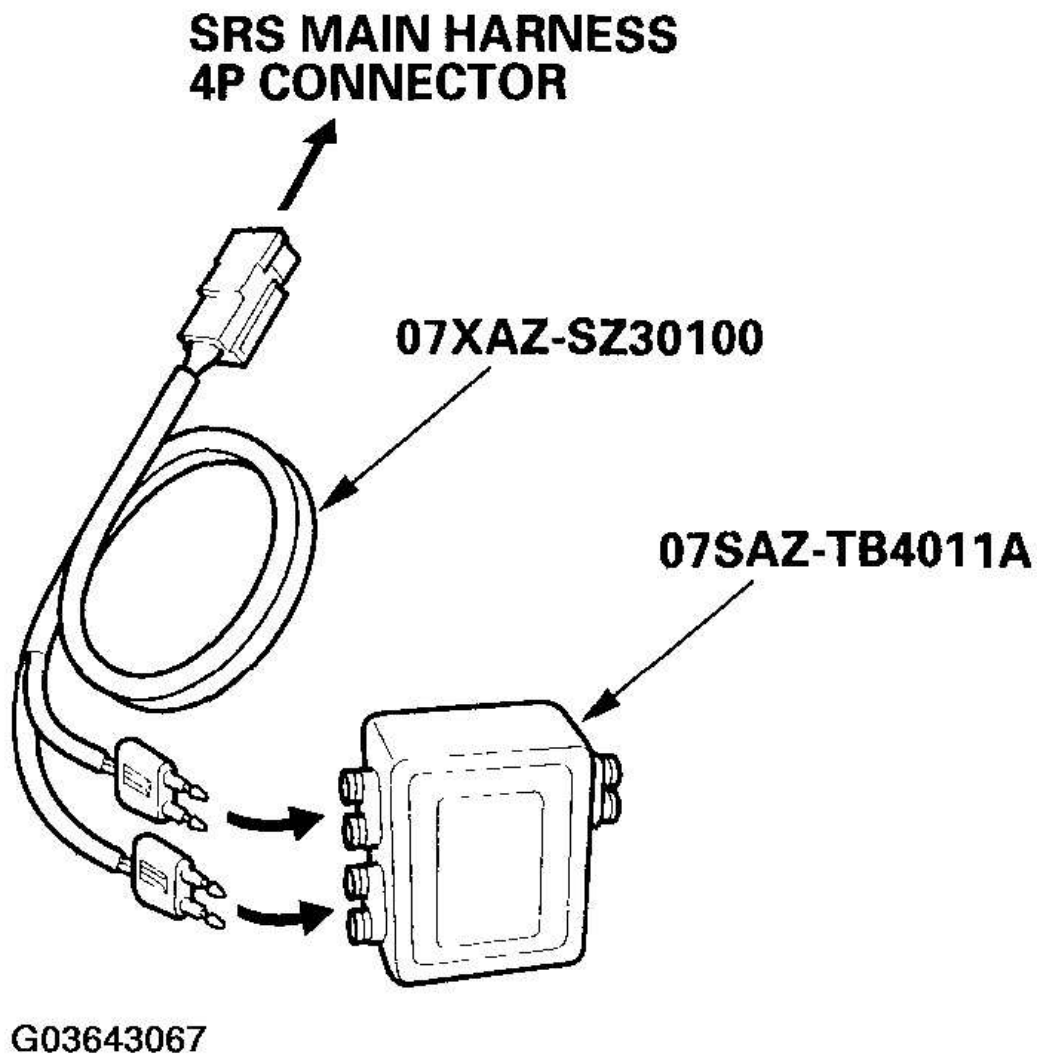
9. Turn the ignition switch OFF. Disconnect the battery negative cable, and wait for 3 minutes.
10. Disconnect SRS main harness 4P connector C812 from the roof wire harness 4P connector (see **ROOF WIRE HARNESS ('04 MODEL)** ).
11. Connect the SRS inflator simulator (2 ohm connectors) and simulator lead F to the SRS main harness.

**Fig. 182: Connecting SRS Inflator Simulator (2 ohm Connectors) And Simulator Lead F To SRS Main Harness**

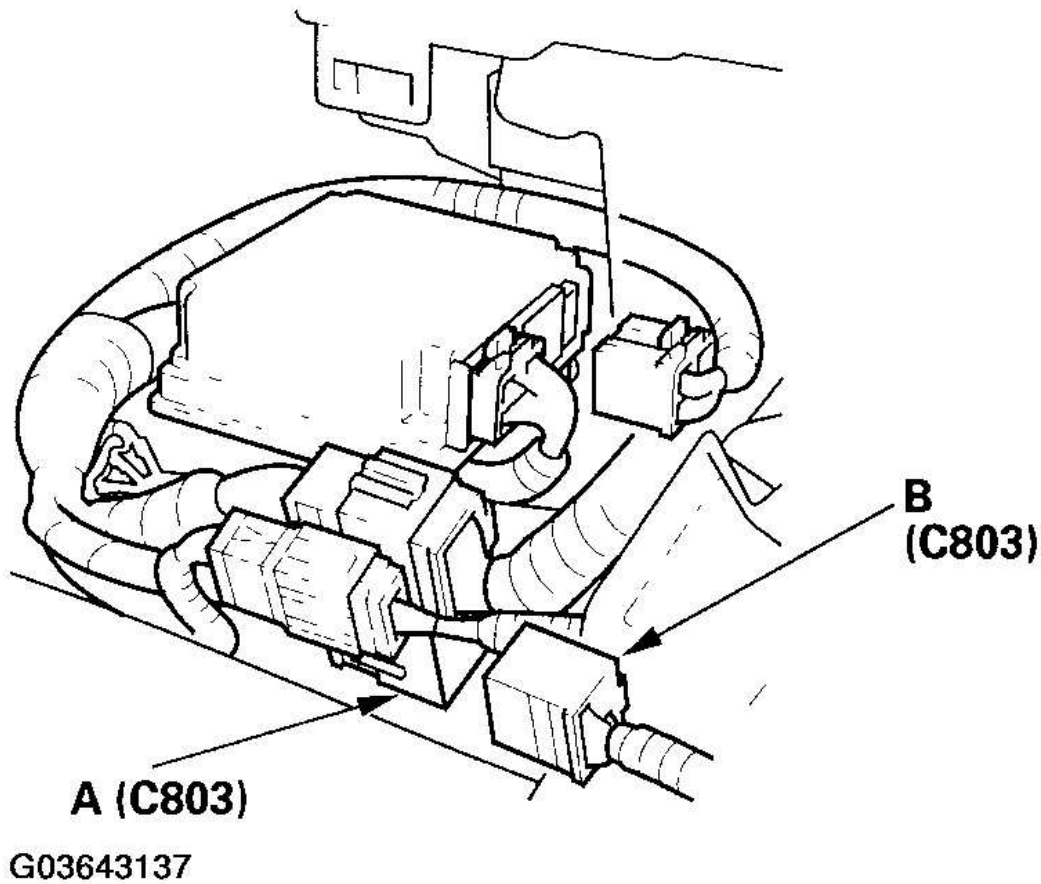
**Fig. 252: Disconnecting SRS Main Subharness 28P Connector C803**  
Courtesy of AMERICAN HONDA MOTOR CO., INC.

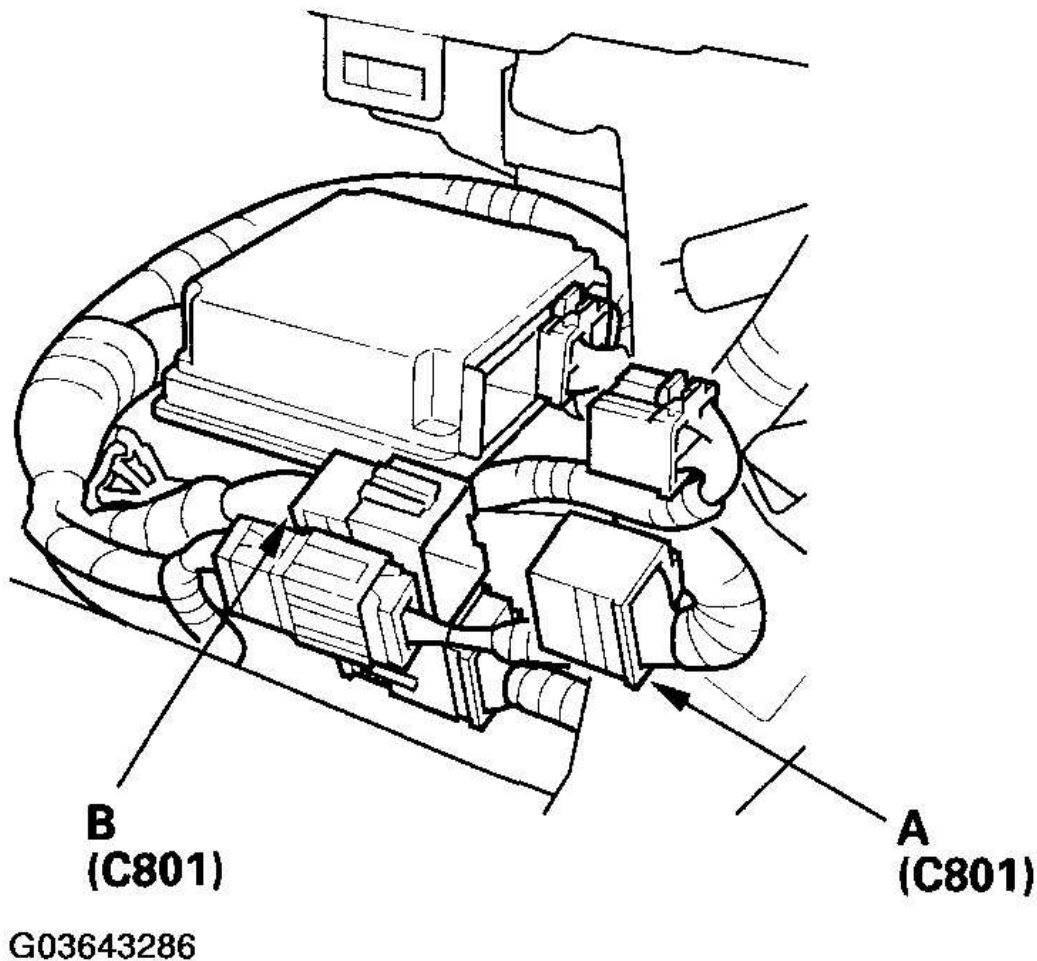
**Fig. 401: Disconnecting SRS Main Harness 28P Connector C801**  
Courtesy of AMERICAN HONDA MOTOR CO., INC.
